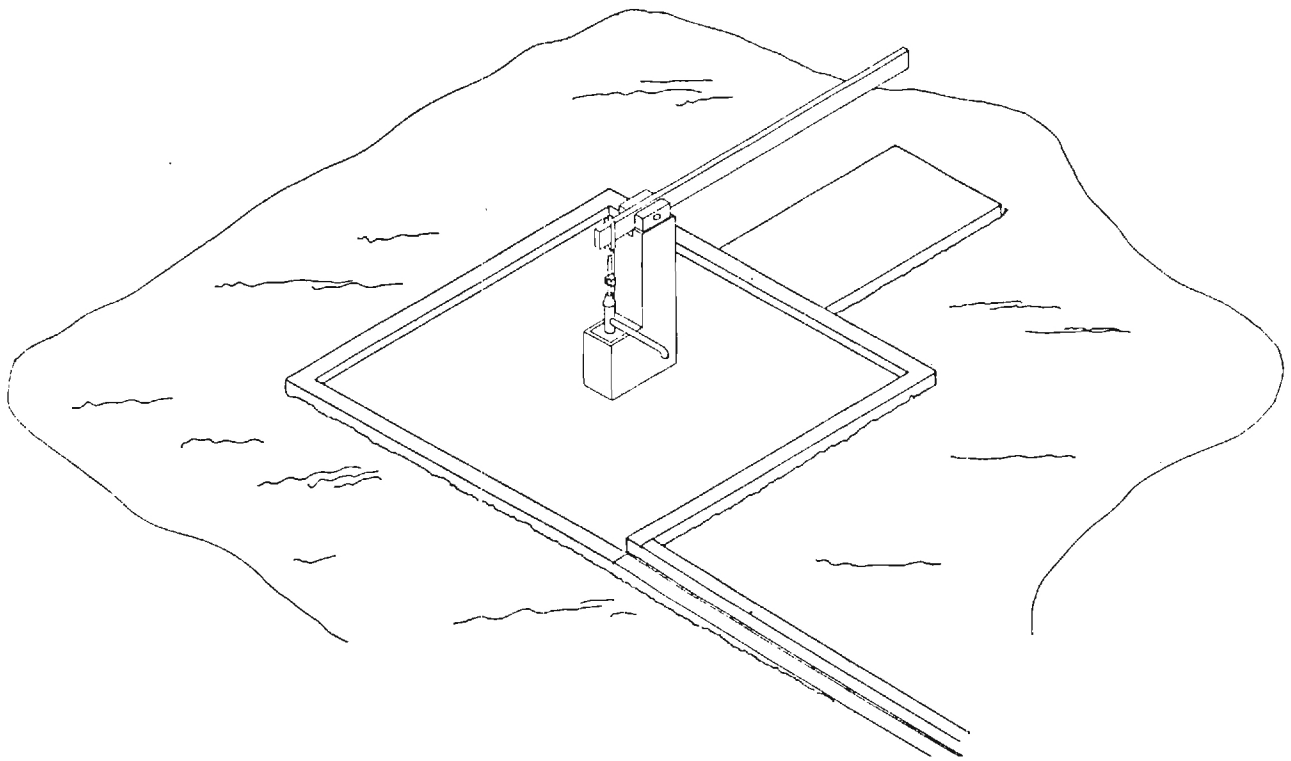
Figure 6.

The Magsaysay hand pump (see Figure 6) is included in BWP activities where wells are extraordinarily deep (100-200 feet static water level); and those observed in the field were working well. Interestingly, this pump has roller bearings at the fulcrum point of the handle, which cuts down friction considerably. The idea of using roller bearings has been discussed from time to time with AID/Washington officials in the AID hand pump; however, this approach has not been laboratory tested, and roller bearings, in many cases, would have to be imported by developing countries.

THE MAGSAYSAY PUMP

Waterworks Development Corporation and is designed for use only in wells where the water table is 25 feet or less. The pump uses a four-inch rubber cup which will not form a seal with the cylinder walls when it has worn down even slightly. This, coupled with a frequent leaky foot valve, requires that the pump sometimes be primed daily or even more often. The local (provincial) engineers who install Jetmatics say that the expected lifetime of a pump used by an average of ten households (sixty people) is about three years. The most common causes of failures are broken cast parts and worn-out bearing surfaces.

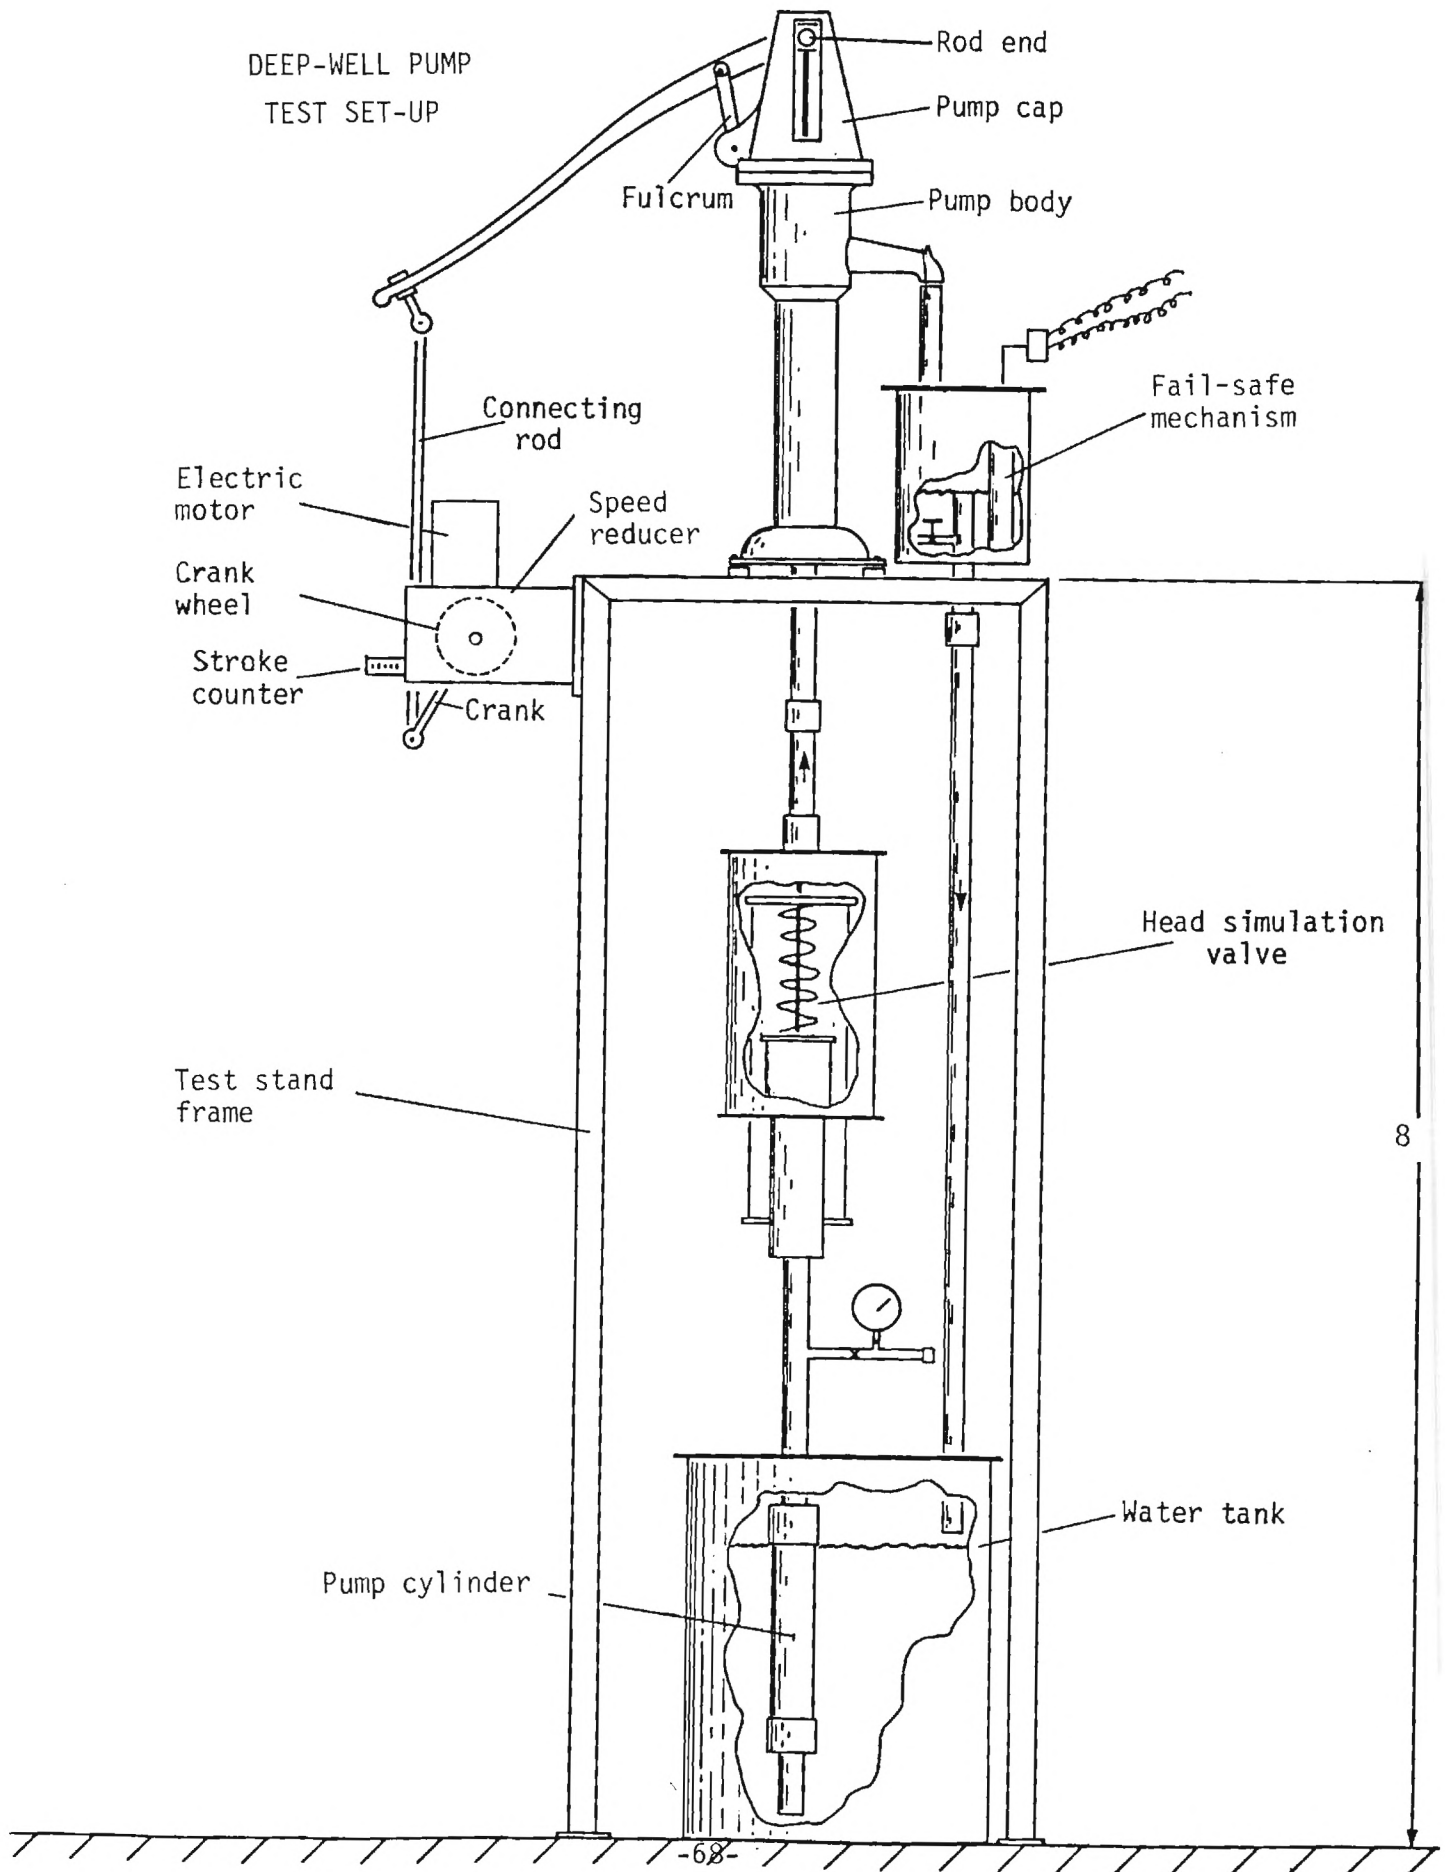
Figure 7.

Georgia Tech hand pump testing facility (see Figure 7) for an inspection of the facility and a review of results from testing pumps (all AID models) from the Philippines, Honduras, Haiti, Dominican Republic, Tunisia and Ecuador. A progress report (see Attachment 2) was distributed which had been prepared by Georgia Tech's Dr. B. S. Dixit for the technical/management review team visit. Not covered in Dr. Dixit's report is the fact that a weighting is being determined for each pump based on casting quality (derived from dimensional measurements and subjective judgment of casting smoothness, voids and inclusions), machining quality (based on dimensional measurements and subjective judgment of threading, hole alignment between connecting components, etc.), and test performance data (based on dimensional measurements of pump components during scheduled inspections for wear during testing, frequency of pump failures during testing, and seriousness of pump failures, if any, during testing). Since none of the pumps have finished a required 10 million cycles of operation, performance data is still incomplete. However, present indications are that the respective pumps will be ranked somewhat in the following order:

1. Philippines (shallow-well and deep-well models)--These pumps appear to be "excellent" in casting, machining and performance.
2. Honduras (shallow-well and deep-well models)--These pumps appear to be "very good." They would be rated "excellent" if not for a leather flapper-type foot valve and some less than desirable machining done without the use of jigs and fixtures.
3. Ecuador (deep-well model)--This pump appears to be "good." It would be rated as "very good" if not for a leather flapper-type foot valve and some less than desirable machining due to poor quality control.
4. Tunisia (modified deep-well model)--This pump has been determined to be "poor and unacceptable." It has machining deficiencies; but its most significant fault is its PVC drop pipe arrangement that serves also as the pump cylinder. It has a tendency for PVC separation at the pipe joints.

5. Dominican Republic (shallow-well and deep-well models)--These pumps have been determined to be "poor and unacceptable." They have considerable casting voids and machining deficiencies such as poor threading, loose bushings, bushings and fulcrum pins that do not come close to specifications (bushings that are hardened to 4 R_C instead of 60-65 R_C, pins that are hardened to 55 R_C instead of 40-45 R_C), leather flapper-type foot valves that do not fully cover the foot valve seat, and poor interchangeability of components.
6. Haiti (deep-well model)--This pump has been determined to be "poor and unacceptable." It has extremely poor casting and machining quality that led to the termination of testing after only 150,000 cycles of testing.
